**CITY OF BALTIMORE WET WEATHER CONSENT DECREE
SMOKE AND DYED WATER TESTING FORM**

Manhole ID: S21M1_016MH

Test ID: 1029-527

CITY OF BALTIMORE
SMOKE TESTING OBSERVATION SUMMARY
LOW LEVEL SEWERSHED
BALTIMORE CITY PROJECT 1029
REI/DRAYCO

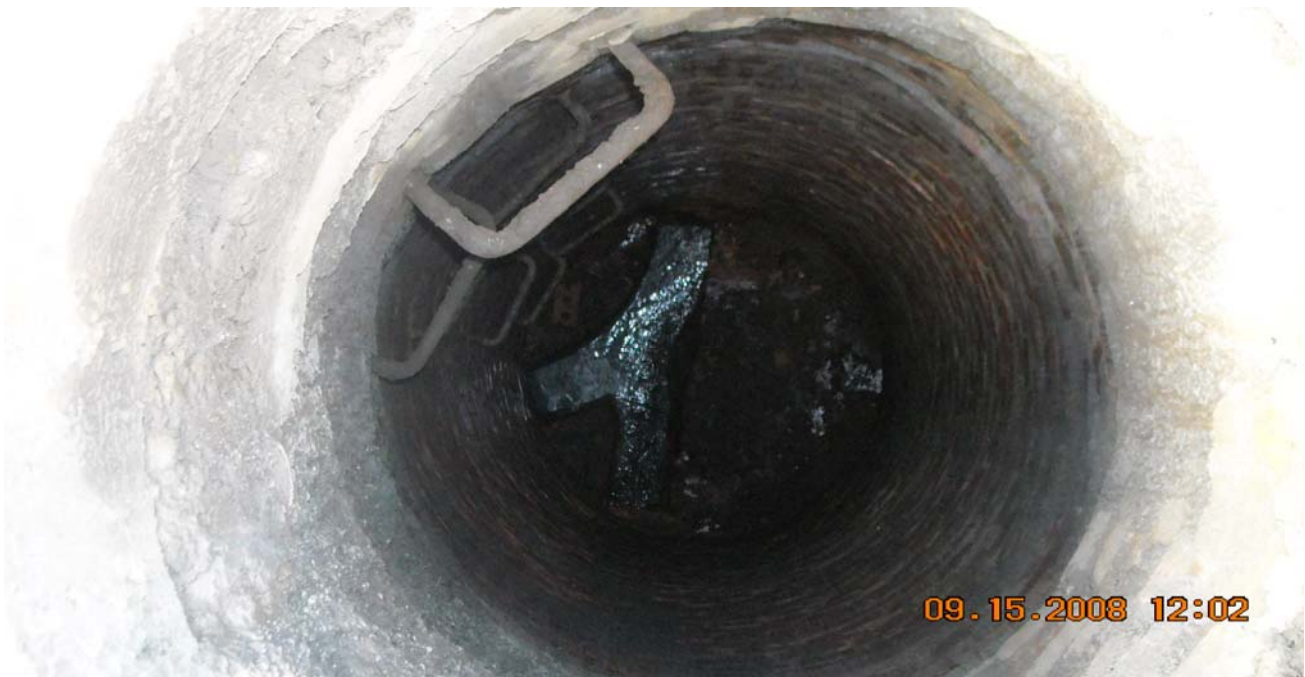
Photograph No: OB01-01
Filename: 1029-527_OB01-01.jpg

Unique Test ID: 527	Date: 09/11/2008	Basin: LL - 41	Manhole ID: S21M1_016MH
Defect No: OB01	Supervisor: E.R.	Crew: 04	Dye Test Recommended: N
Address: S21M1_016MH			
Source Type: 01 Main Sewer		Location: 02 Asphalt	
Sector: 01 Public		Severity: 01 No Smoke	Drainage Area: 0
Comments: MANHOLE S21M1_016MH CONNECTS TO AN UNMARKED MANHOLE BEHIND SHOPPING CENTER.

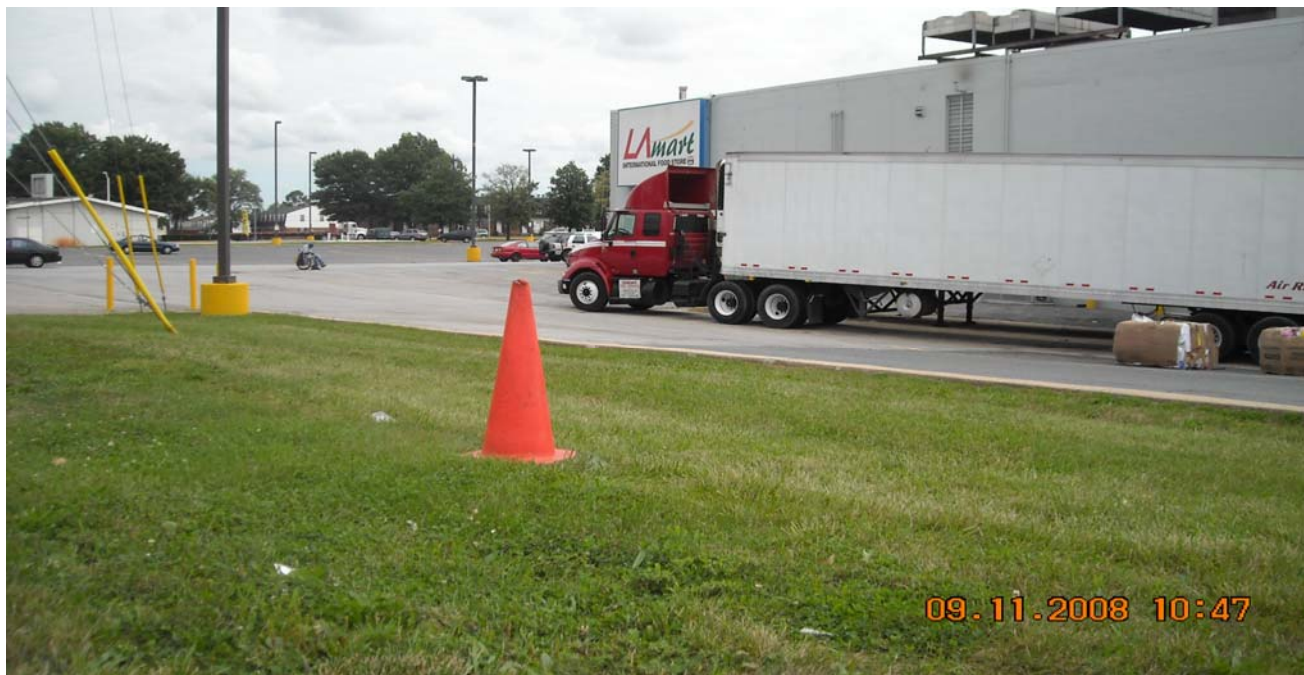
Photograph No: OB02-01
Filename: 1029-527_OB02-01.jpg

Unique Test ID: 527	Date: 09/11/2008	Basin: LL - 41	Manhole ID: S21M1_016MH
Defect No: OB02	Supervisor: E.R.	Crew: 04	Dye Test Recommended: N
Address: S21M1_016MH

Source Type: 01 Main Sewer

Location: 11 Field/Woods

Sector: 02 Private

Severity: 03 Moderate

Drainage Area: 4

Comments: SMOKE COMING FROM HOLE IN GROUND IN FRONT OF ORANGE CONE. SMOKE DID NOT COME OUT OF S21M1_016MH AS EXPECTED, BUT DID COME OUT OF UNMARKED MANHOLE AS LOCATED ON MAP.

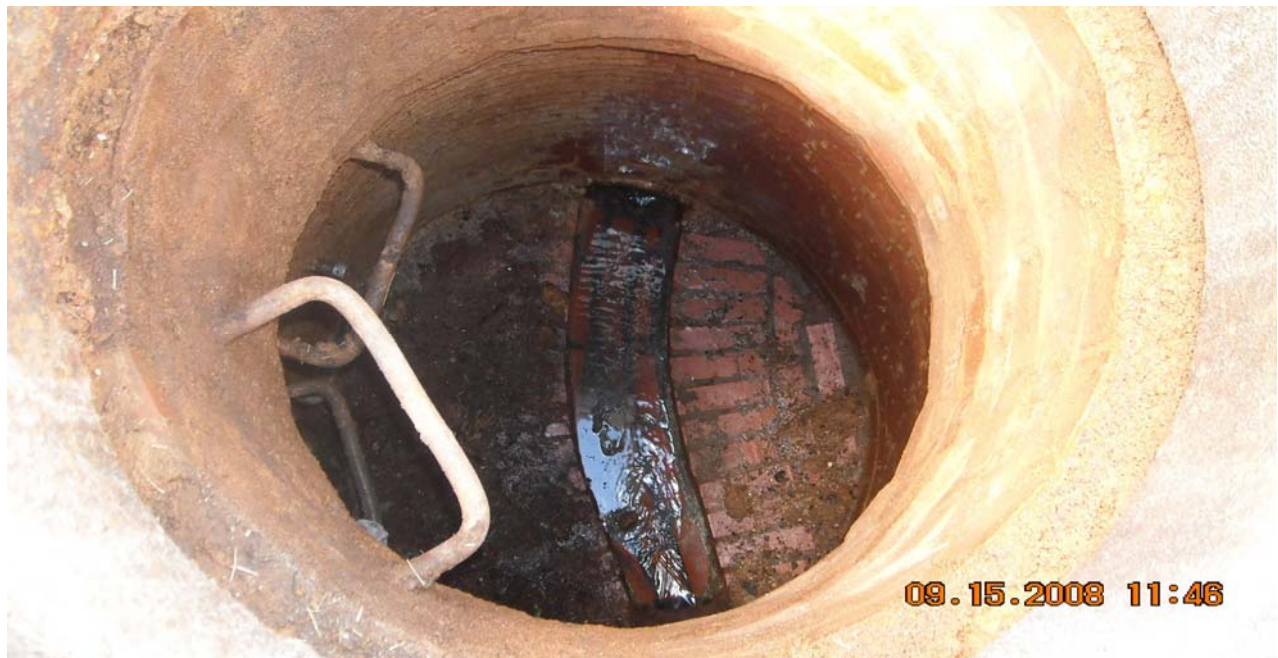
Photograph No: OB03-01
Filename: 1029-527_OB03-01.jpg

Unique Test ID: 527	Date: 09/11/2008	Basin: LL - 41	Manhole ID: S21M1_016MH
Defect No: OB03	Supervisor: E.R.	Crew: 04	Dye Test Recommended: N
Address: 2135 W. PATAPSCO AVE.			
Source Type: 01 Main Sewer		Location: 02 Asphalt	
Sector: 02 Private		Severity: 01 No Smoke	Drainage Area: 0
Comments: SMOKE WAS COMING OUT OF THIS UNIDENTIFIED MANHOLE WHEN BLOWN OUT OF S21M1_016MH.
